Assessment of Fluvial Geomorphology in Relation to Erosion and Landslides in the Mad River Watershed in Central Vermont

June 3, 2003

FINAL DRAFT

Vermont Geological Survey

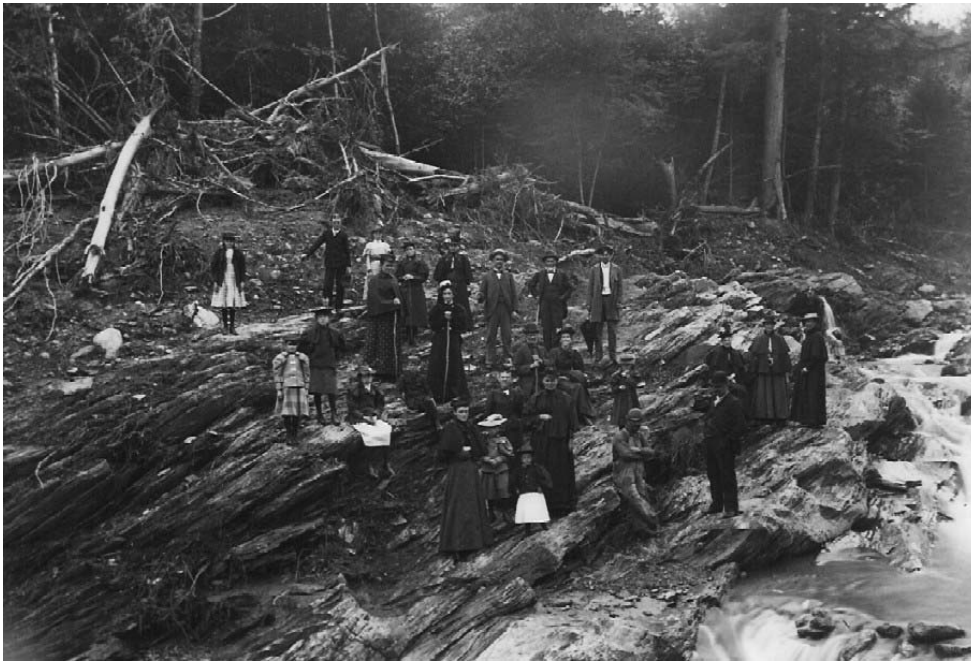
Four large landslides have been recorded in the valley. They occurred in 1812, 1827, 1840 and 1897 (Figure 3). The 1897 slide occurred in generally the same path as the 1827 slide. The historical accounts give conflicting information on the location, one places it in Clay Brook, and another on a tributary of the Mill Brook (probably Slide Brook). A Waitsfield resident can look west from his house to see the slide scar, so that indicates that the location of the 1827 and 1897 slides was probably on Slide Brook (Marsh, personal communication, 2002). The following information on landslides is from historical records researched by Earline Marsh (1998-2000), a historian in Moretown. Further historical accounts on landslides are in Appendix B.

Figure 3: 1897 Fayston Landslide

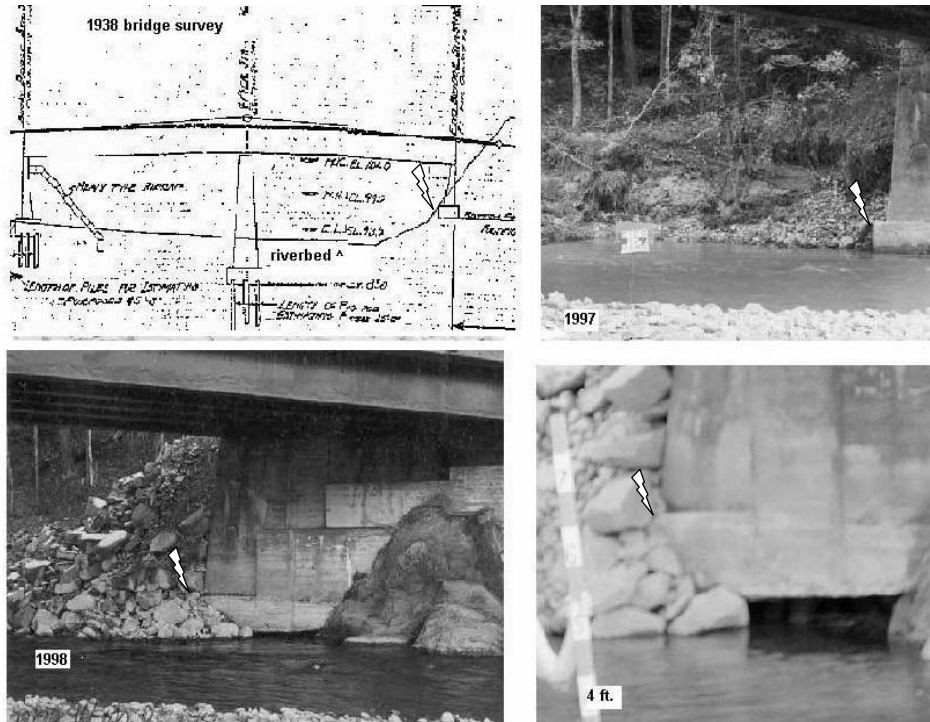
“By 1985 DEC was observing indicators of extreme streambed degradation, or a lowering of the streambed elevation. The most important indicator was that much of the bank armoring that had been installed 2 feet below streambed was now totally exposed and the streambed in several locations was as much as 1.5 feet below the bottom of the blanket; a change of up to 3.5 feet in less than 15 years!

Much of the rip rap was failing as a result. The excessive gravel excavation was threatening to destroy much of the hundreds of thousands of dollars in investment in bank stabilization done just a few years before.” (VT ANR, February, 1999).

Figure 12: Degradation at Route 100 Bridge upstream of Waitsfield. 1938 shows bed elevation and low, mean and high water levels. P. 1998 from Vermont Agency of Transportation. 2002 shows increased degradation, note staff gage for scale. Middle pier [not in photo]

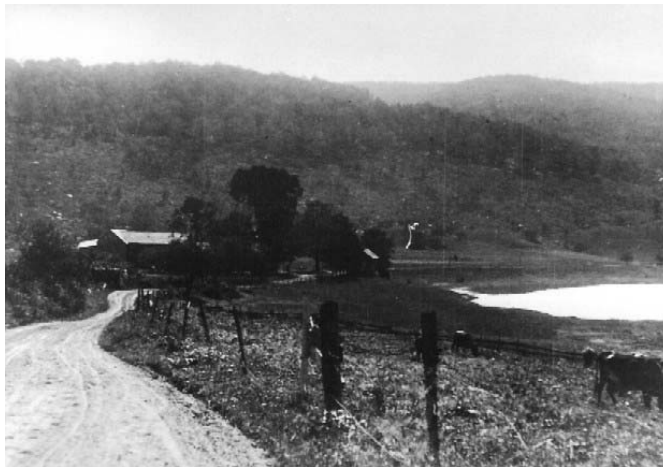
Figure 19: Pond above Lovers Lane Dam, pre -1927 flood. Reach M2

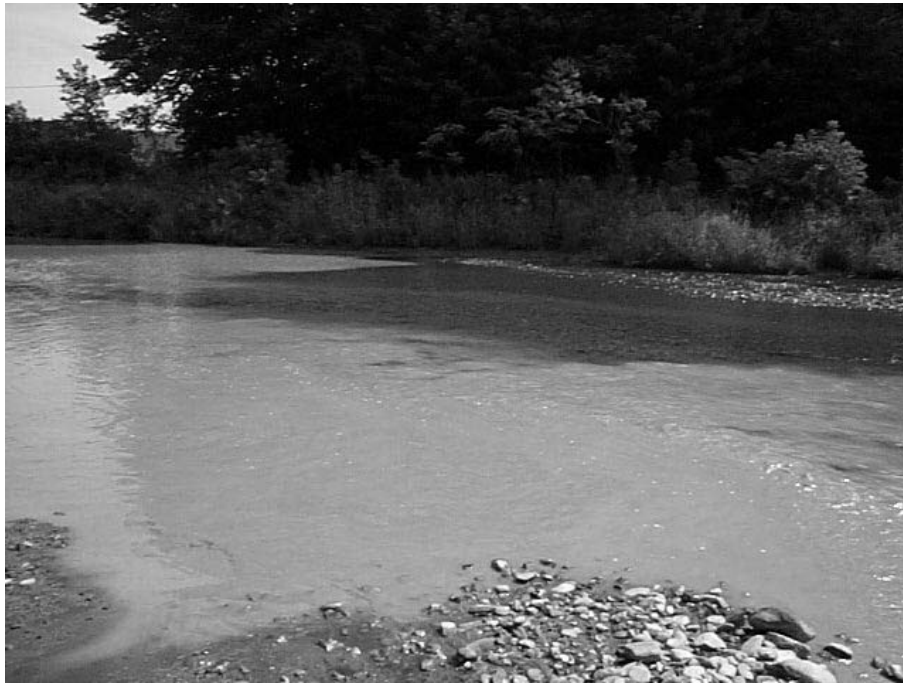
During the 1998 flood, the snow-making pond on Clay Brook and a private pond on Lincoln Brook failed causing damage downstream when the sediment load was released. In 2001, an un-named tributary, M11-S4, had a private pond that breached. Due to the low-flow of the drought year the sediment plume (Figure 20) from this failed pond was evident for several days as it moved downstream. Small weirs are located on several tributaries including Slide, Chase, and a Mill Brook Tributary (T7.1-S3) and a flume is located on Clay Brook.

Figure 20: Sediment plume in Mad River from breached pond on un-named Tributary M11-S4. Low-flow conditions on Mad River.
