Assessment of Fluvial Geomorphology in Relation to Erosion and Landslides in the Mad River Watershed in Central Vermont

June 3, 2003

FINAL DRAFT

Vermont Geological Survey

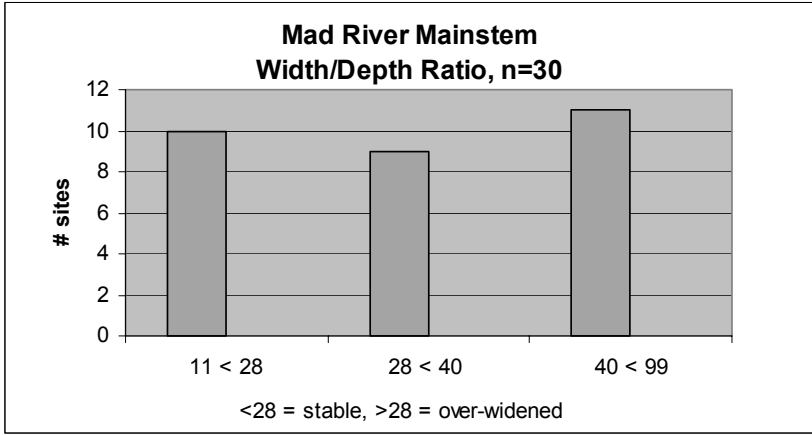
Figure 4: Mainstem Width/Depth Ratio. Approximately 2/3 of cross-sections are over-widened.

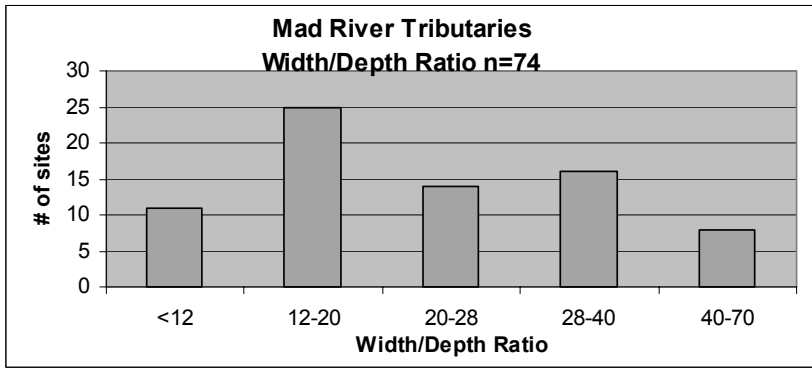
Figure 5: Tributary Width/Depth Ratio. Approximately 1/3 of cross-sections are over-widened

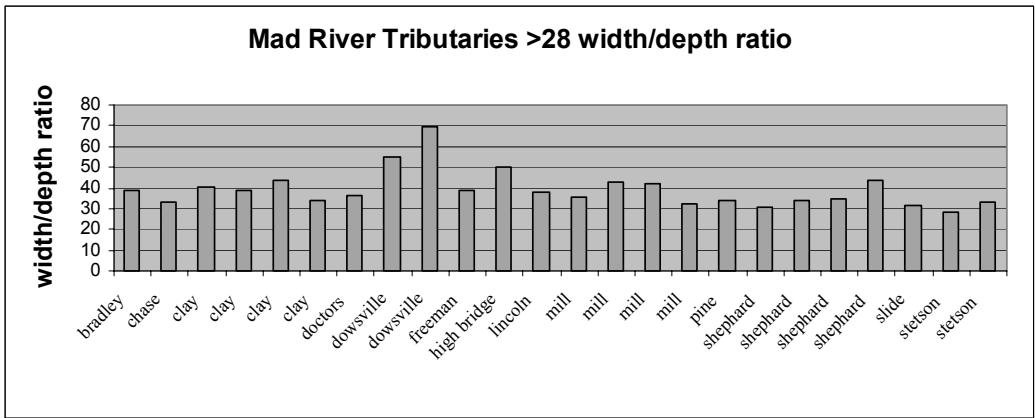
Figure 6: Over-widened Tributaries. Higher width/depth ratios indicate decreased ability to adequately transport sediment.

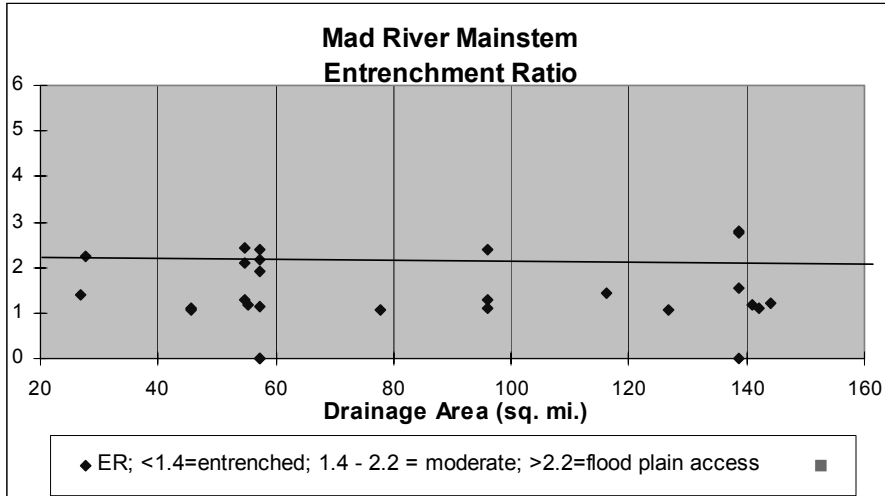
Figures 8 and 9 show the entrenchment ratio (ER). The ER is determined by dividing the floodprone width (width at 2 x maximum depth) by the bankfull width. Streams with an ER greater than 2.2 access the floodplain during bankfull events (Rosgen, 1996). Approximately one-third of the basins under 10 sq. miles have flood plain access, however on the mainstem of the Mad River (over 20 sq. miles drainage area), the majority of the cross-sections do not have access to the floodplain; they are moderately to greatly entrenched.

Figure 8: Entrenchment Ratio: Mainstem The majority of cross-sections do not have flood-plain access.

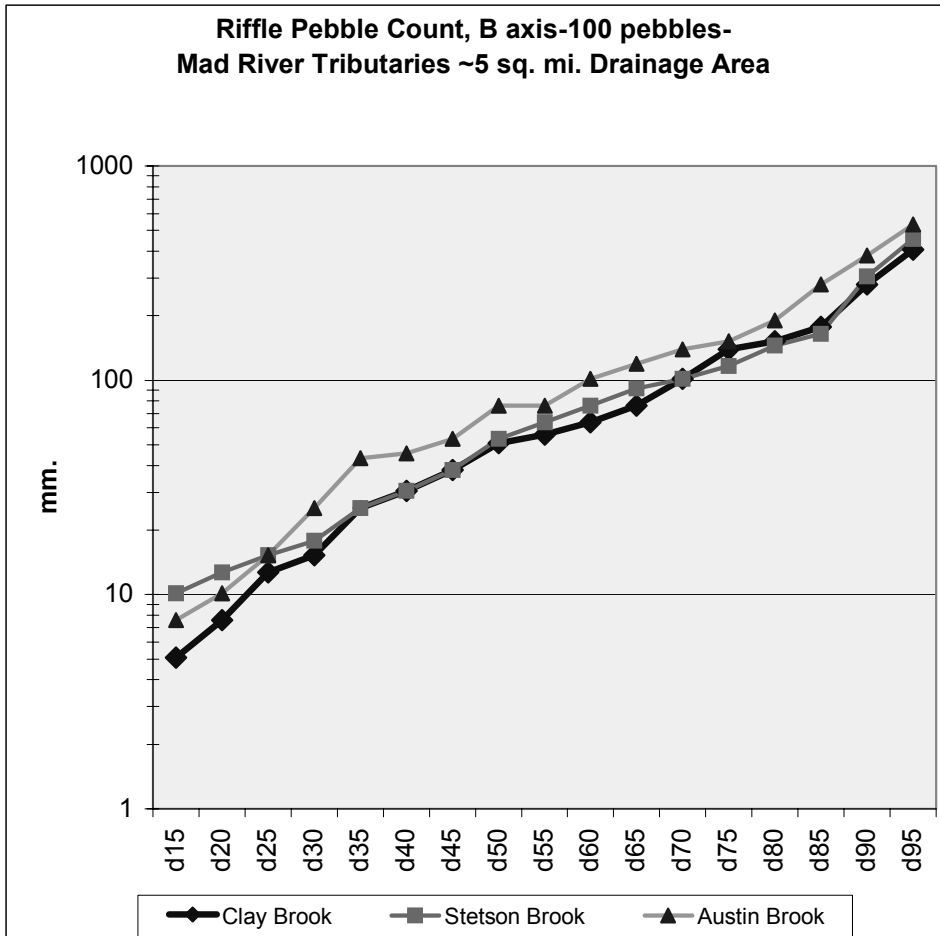
Pebble counts were conducted at riffles on 3 streams in the southwestern part of the watershed with drainage areas of ~5 sq. mi. Figure 13 shows a decrease in diameter (d) of particles less than or equal to <d30 on Clay Brook. This stream is listed on the ANR impaired waters (303-D) list as degraded due to sediment.

Figure 13: Pebble Count: Three watersheds. Note decrease in size less than D30.

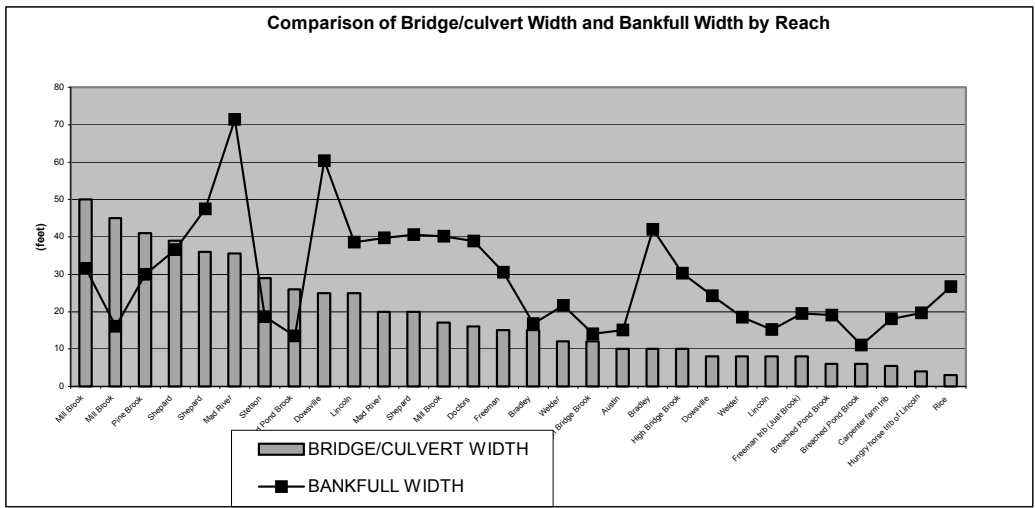
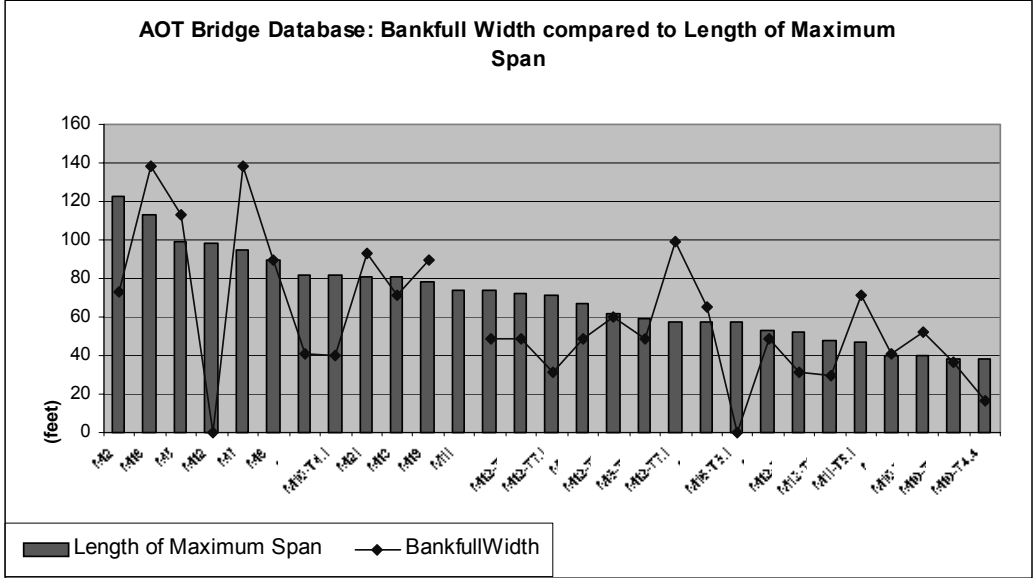
Data on bridge or culvert width was measured in the field by professionals and volunteers (Figure 14), or derived from VT Agency of Transportation database using parameter titled “length of maximum span” which goes from abutment to abutment (Figure 15). Cross sections and bridges were measured within the same reach, but not at the same location. Cross sections *were surveyed* away from the influence of bridges or culverts. Figure 15 shows that in the majority of cases, the channels were significantly constricted by either bridges or culverts.

Figures 14 and 15: Comparison of Bridge/Culvert and Bankfull Width, sorted by width of structure. Where dotted line intersects vertical bars, the structures do not constrict the channel. Where dotted line is above the bars, the structure constricts the channel at bankfull flows. The majority of structures are smaller than bankfull width. Bankfull width was measured in each reach.
